Appendix C
Philips Installed Base for All AEDs and AED CPF Rates
January 1997 – December 2003

Attachment 1
Summary of MDR Reportable Events for All ForeRunner and FR2 Defi
December 1996 - December 2003

Attachment 2
Summary of Device Failures for All ForeRunner, FR2, and HeartStart HS1 Defibrillators
December 1996 - December 2003

Attachment 3
ECG Record of Single Reported “Inappropriate Shock” and Independent Review by Final Overreading Physician

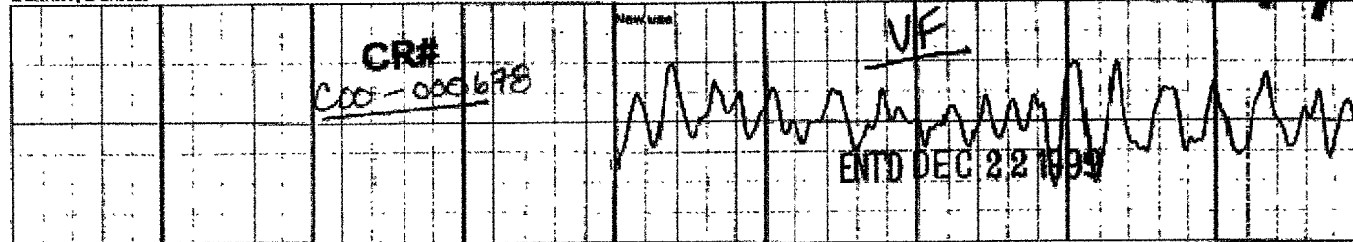
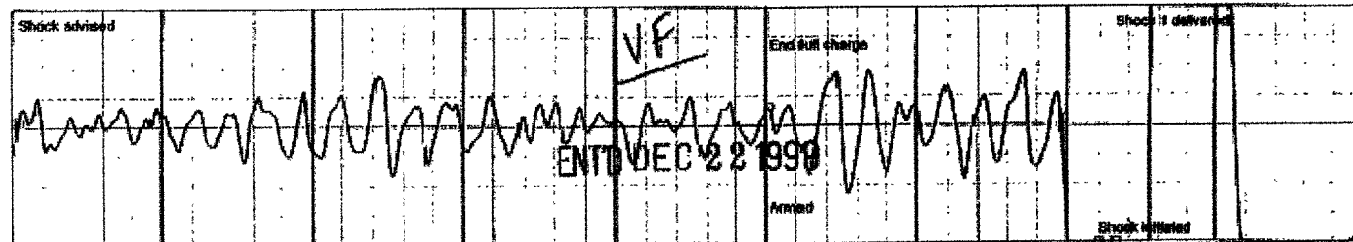
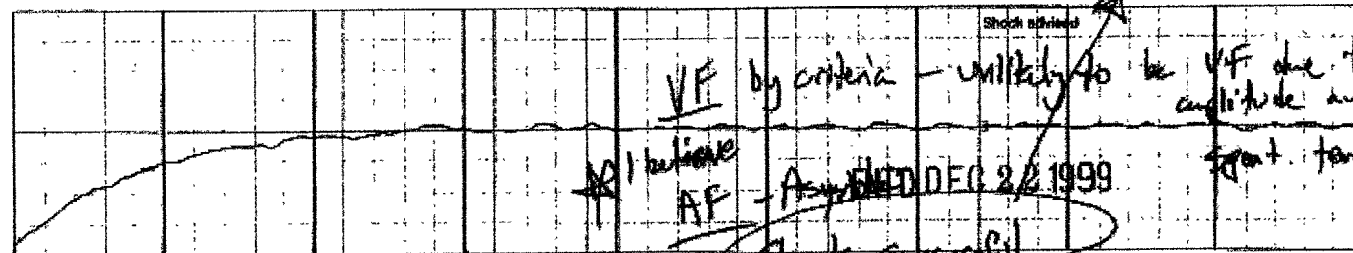
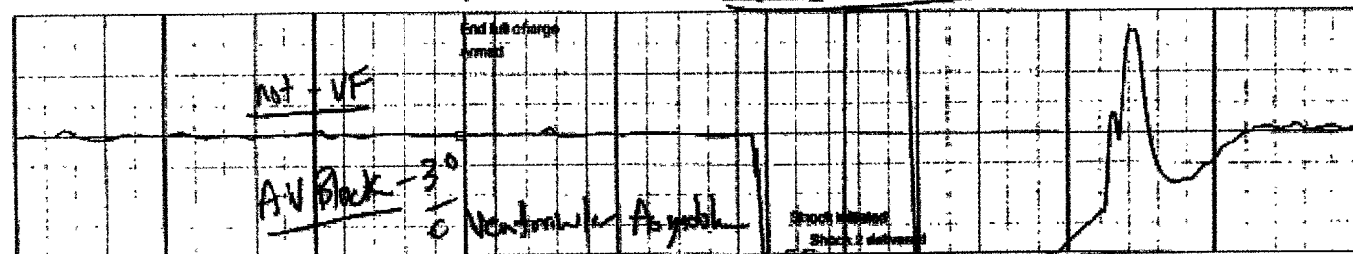
ENTIRE ECG
Incident ID : Brug061

Incident Date: 11/22/98
